INTELLIGENT CONTROL SYSTEM FOR MONITORING THE MAINTENANCE OF THE CENTER PIVOT IRRIGATION SYSTEM

S. M. Ismail¹, T. K. Zin El-Abedin¹, A. M. Shawky² and A. Abd El-Al³ &*

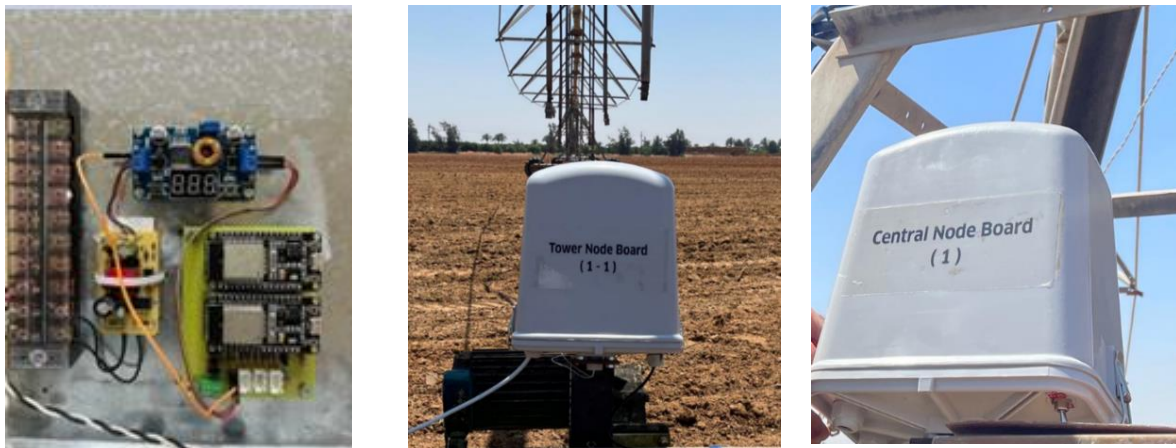
Figure (5): Components and position of Tower and central Node Board

Installing the tower node board for each tower is mandatory to be able to collect the vital readings for the gearmotor, gearboxes, and tire pressure for each tower. Each node board consists of two ESP32 microcontrollers Fig. (4). one of these microcontrollers is responsible for collecting data from the wired sensors and transmitting it between towers via the ESP NOW protocol, while the other manages the Bluetooth connection with the tire pressure sensors. The main components tower node board are shown in Figure (5).

The components of a central node board are identical to those of a tower node board, but they serve different purposes and are positioned differently. A central node board is mounted next to the center Pivot's control panel (Figure 5), and it gathers and transfers all of the crucial data from all tower node boards to the cloud server via the internet. It can also be used to control the gadget remotely.

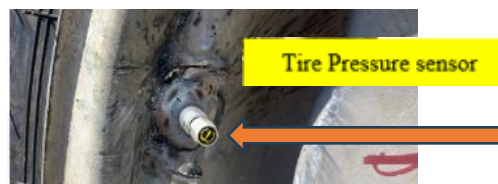
Figure (14): The tire pressure sensor installation.

- one Tire pressure sensor was used in each tower (one at the front tire) as shown in Figure (13) and (14).
- Two temperature sensors were used in each tower (one at the gearbox and one at the gearmotor) as shown in Figure (13) and (15 a, b).
- Two Oil level sensors were used in each tower (one at the gearbox and one at the gearmotor) as shown in Figure (13) and (16 a, b).
- Two Node Board were used in each tower (one at the center and one at each tower) as shown in Figure (13) and (17 a, b).

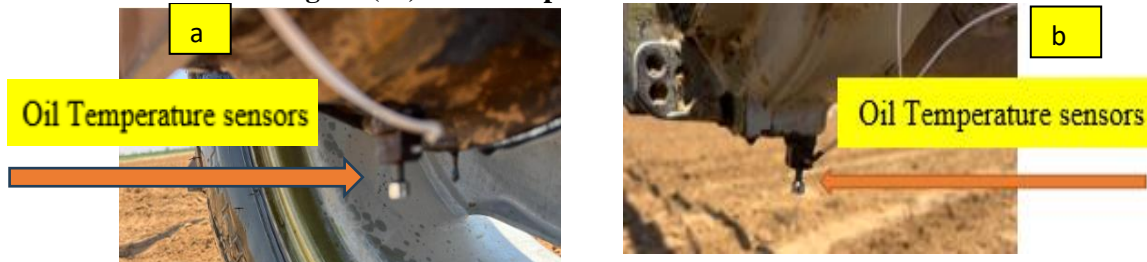
Figure (15): a- The temperature sensor of gear box installation, b-The temperature sensor of gear motor installation.
